Chooralmala, Wayanad, Kerala, India

Landslide Impact Map

Observed on 04/07/2024

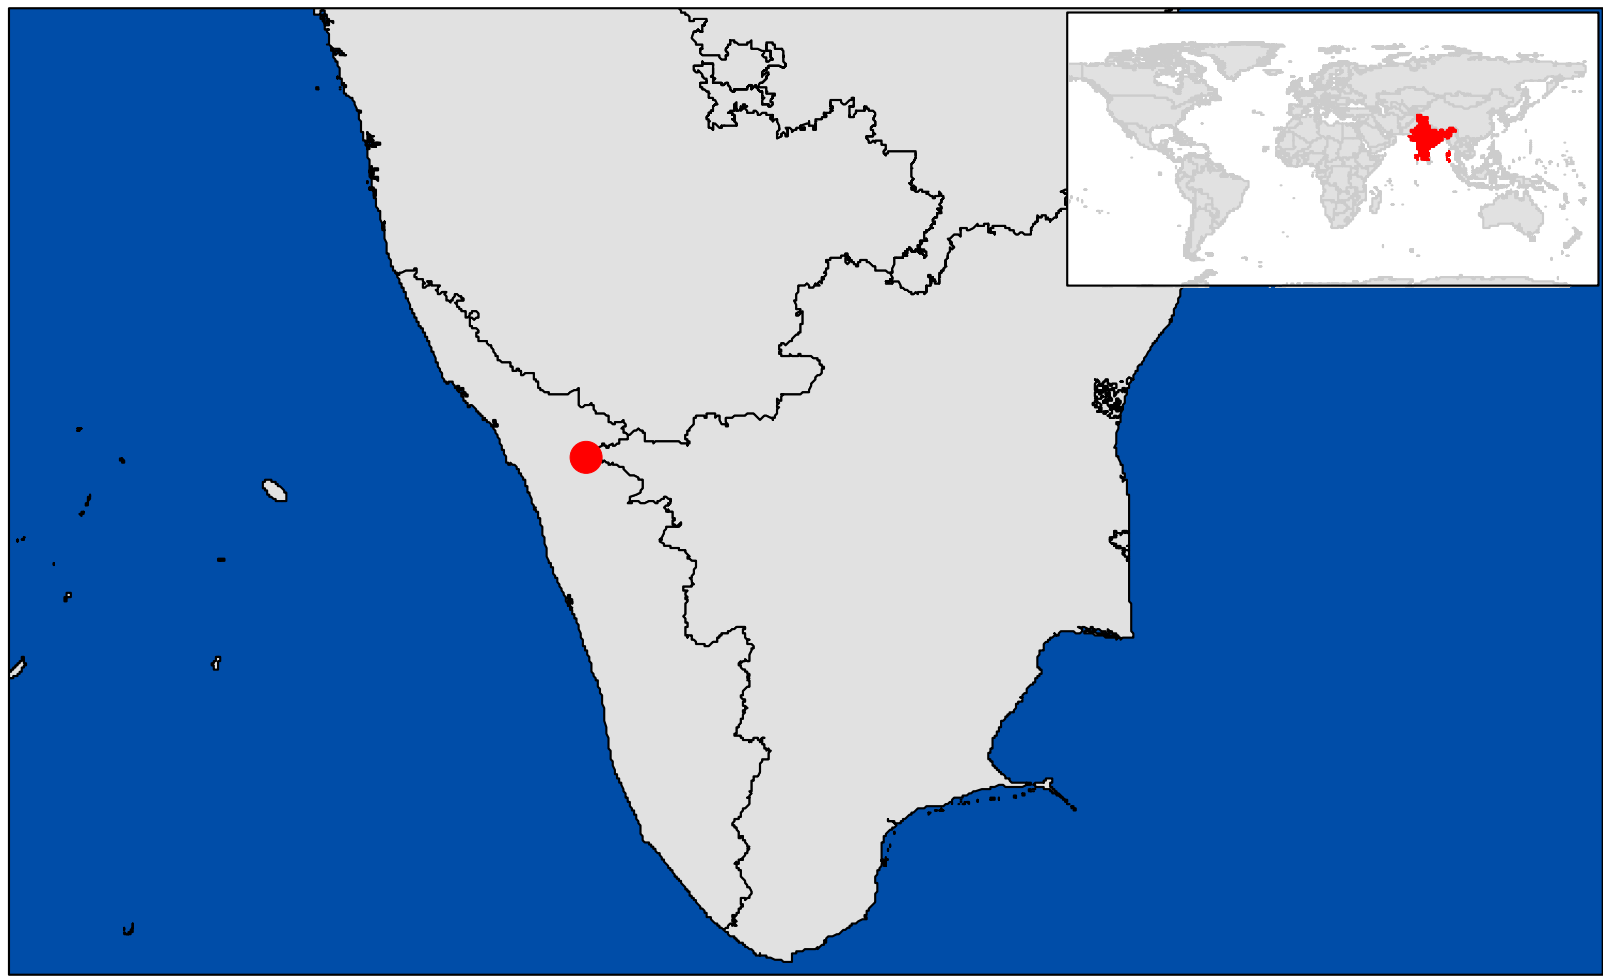
Location Diagrams

A major debris flow was triggered by heavy rainfall in and around the Chooralmala town of Wayanad District in Kerala state of India. As per latest reports, more than 300 people are dead and many are missing. Very high resolution BLACKSKY optical imagery of 4 August 2024 shows the extent of damage in and around:

- a. Mundakkai town and surroundings
- b. Settlements south Chooralmala town
- c. Within Chooralmala town
